The World Standard in Concrete Waterproofing by Crystallization

XYPEX - THE CRYSTALLINE DIFFERENCE

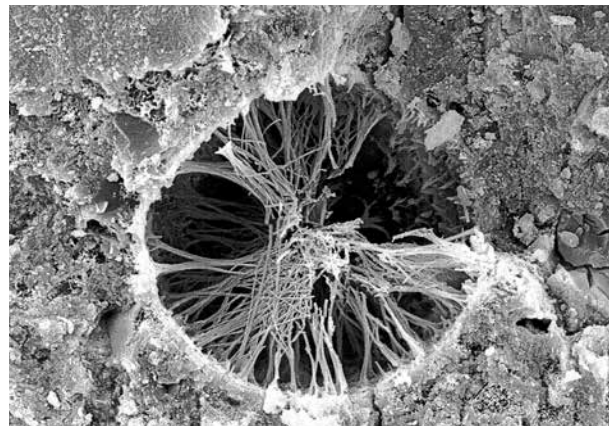
XYPEX TREATED CONCRETE

In the following pages, using the high-power imaging capability of a Scanning Electron Microscope (SEM), we display visual evidence that clearly differentiates Xypex from all other products in the waterproofing admixtures category. SEM is a technique whereby a precise photographic image of a microstructure is produced by scanning it with a focused beam of electrons. Extremely high degrees of magnification can be attained and, at x500 magnification, Xypex crystalline formations at work can be seen.

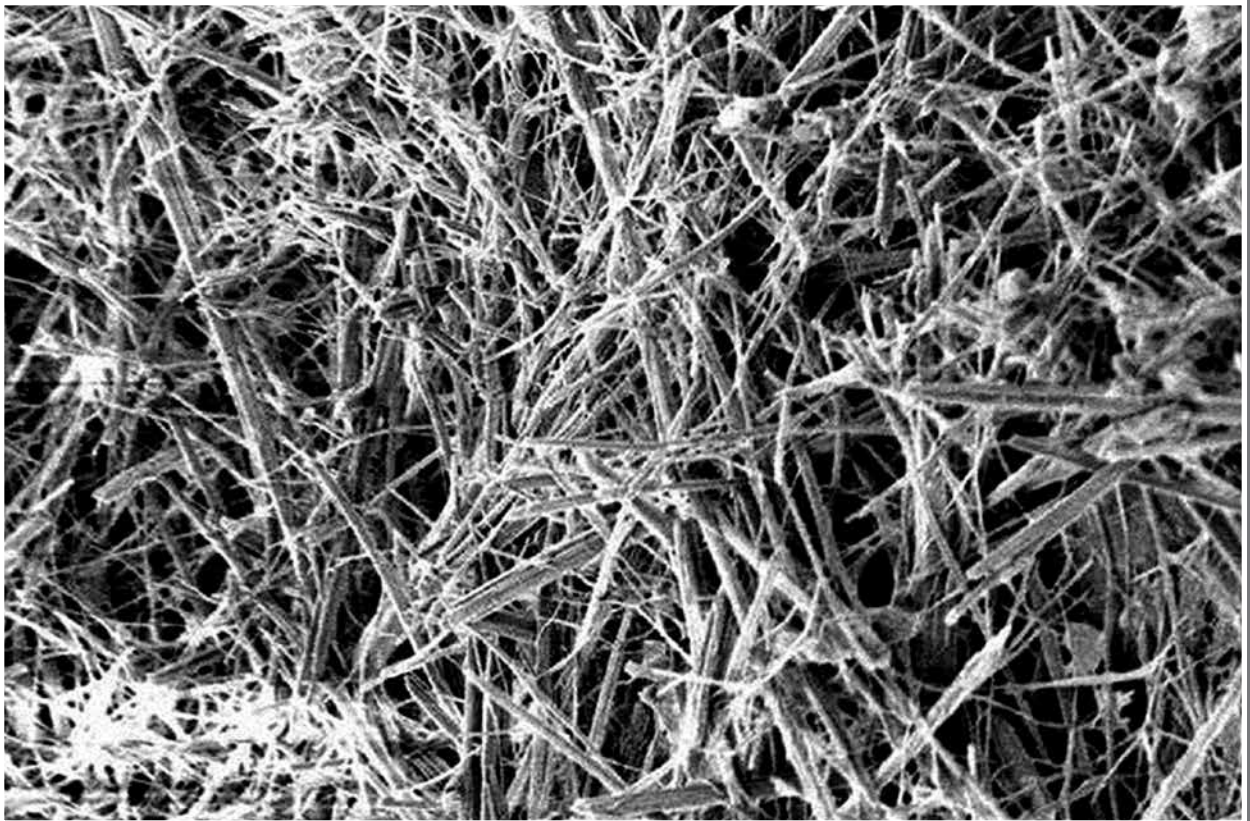
AUSINDUSTRY START GRADUATE PROGRAM
SEM-105

As part of an extensive test program, samples were subject to water pressures equivalent to 100 m (330 ft.) of head. The 50 mm (2 in.) thick Xypex treated samples showed no signs of water penetration at this pressure, whereas the untreated control samples leaked even at 60 m (196 ft.) of water head. Below we see an SEM image of a Xypex treated sample at 2500x magnification. Note the dense mesh of Xypex crystals.

XYPEX TREATED CONCRETE

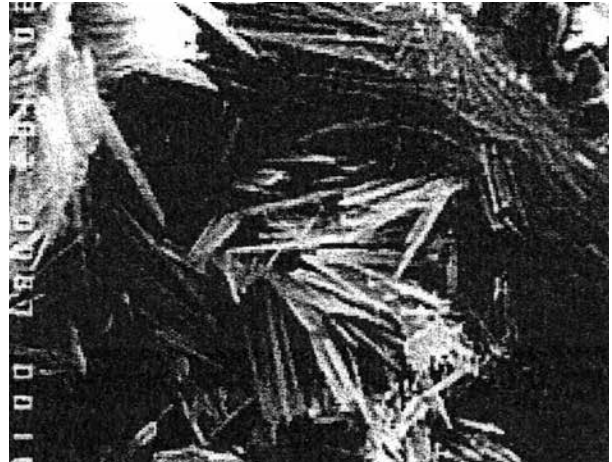
CIVIL ENGINEERING SOCIETY OF JAPAN
SEM-102

XYPEX TREATED CONCRETE

The Hokutoh road-traffic bridge in Japan, constructed in 1972 suffered extensive cracking with widths of 0.1 – 0.2 mm allowing the penetration of water and de-icing salts. After treatment on the lower side of the bridge deck with Xypex Concentrate, cores were taken and subjected to 2 kg/cm² (29 psi) of pressurized water over time. Whereas the untreated areas continued to leak, all of the Xypex treated areas healed and leaking stopped.

In the SEM image, taken from concrete samples at 6 – 10 cm (2 – 4 in.) beneath the Xypex coated surface of the concrete, we can see how Xypex Crystalline Technology healed the cracks and stopped the leakage.

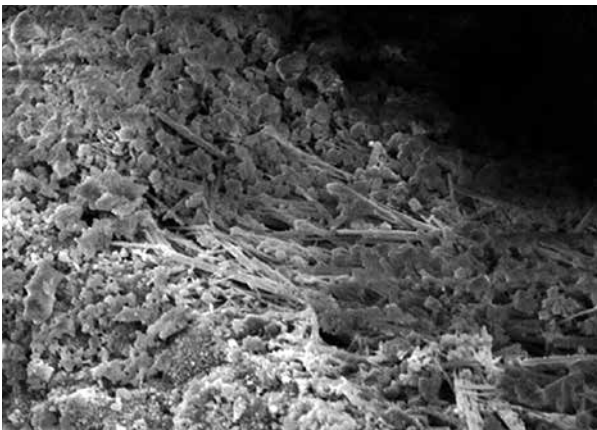
STREC – CHULALONGKORN UNIVERSITY THAILAND
SEM-112

Experts investigated Xypex's crack-healing ability for cracks wider than 0.4 mm. In a sample taken from an in-service pre-cast element, the crack measured from 1.0 – 1.5 mm. From the x1000 imagery, taken at 28 days, it is evident that even in wider cracks Xypex crystals are forming.

XYPEX TREATED CONCRETE

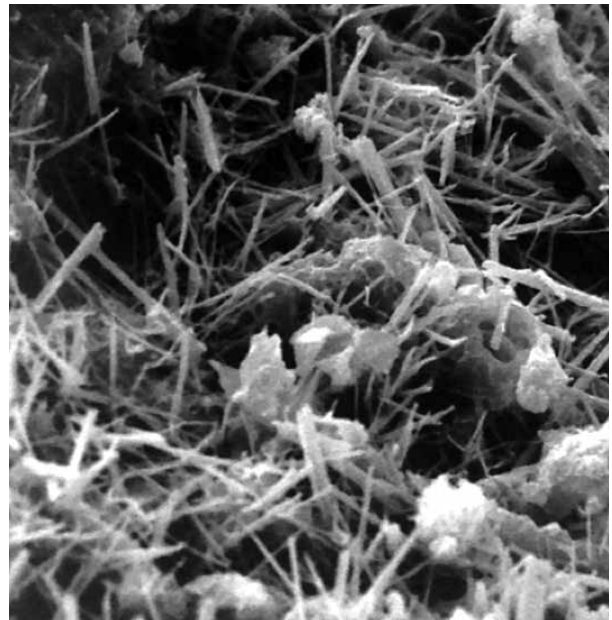
XAYABURI HYDROELECTRIC POWER PLANT, LAOS
SEM-114

As part of the approval process, Xypex treated concrete was subjected to crack-healing testing. Concrete panels were cast, cracked by force and subjected to ponding of water over the cracks to measure the flow. The untreated control samples had cracks with an average width of 0.23 mm and continued to leak beyond the 25 day limit for the test. The Xypex treated panel had cracks with an average width of 0.38 mm and leakage through the cracks stopped after just four days. This was a site demonstration of the crack-healing abilities of Xypex and was subsequently captured in this SEM image.

XYPEX TREATED CONCRETE

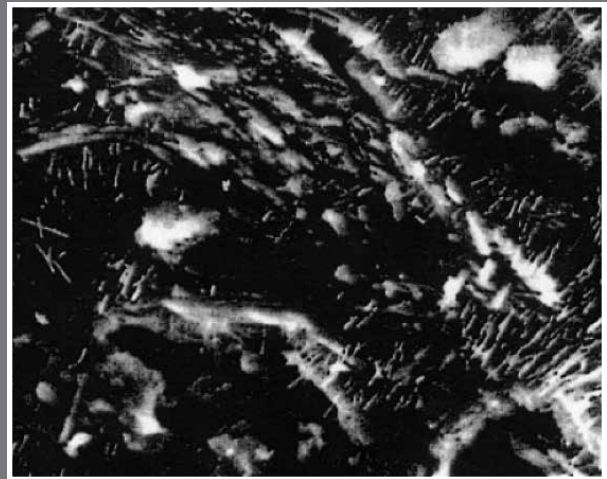
CIVIL ENGINEERING SOCIETY OF JAPAN
SEM-100

Here, a sample of concrete coated with Xypex Concentrate on the negative side was left exposed to the environment for 12 months. SEM images were then taken of samples at different depths from the surface of the concrete. We can see evidence of crystalline growth at 300 mm (12 in.) from the surface of the concrete.

XYPEX TREATED CONCRETE

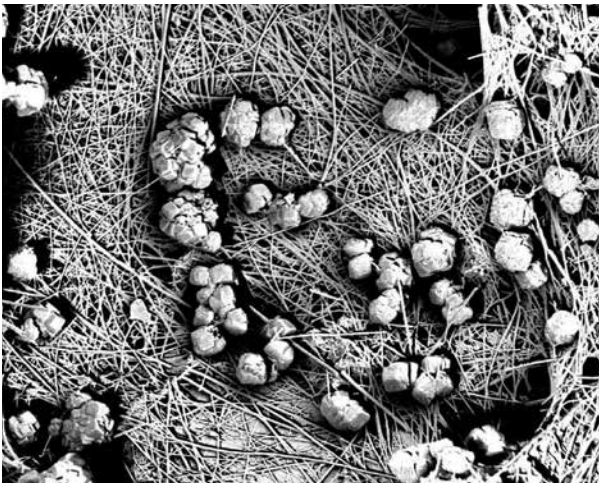
In this study, investigators wanted to understand how Xypex Admix reacts with supplementary cementitious materials (SCMs) such as blast furnace slag and fly ash. In this first image, taken at x2000 magnification, we can clearly see the Xypex Crystalline formation in a highly dense, 50 MPa (7,250 psi) compressive strength concrete containing a 60% slag blended cement.

XYPEX TREATED CONCRETE
(60% SLAG BLENDED CEMENT)

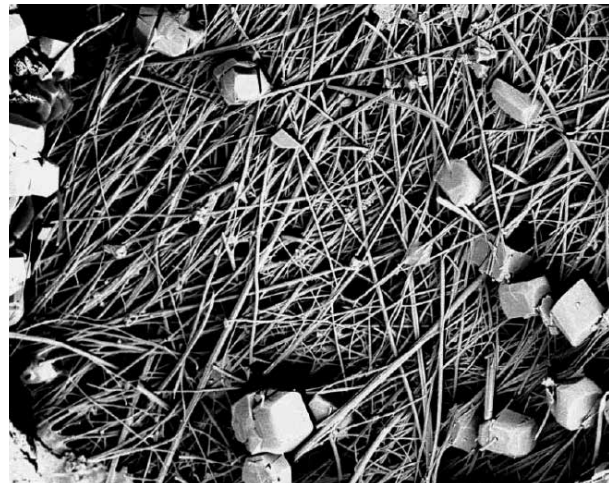
In this next image, again at x2000 magnification, we can see the Xypex Crystalline formation in a 65 MPa (9,425 psi) compressive strength concrete containing a 30% fly ash blended cement.

XYPEX TREATED CONCRETE
(30% FLY ASH BLENDED CEMENT)

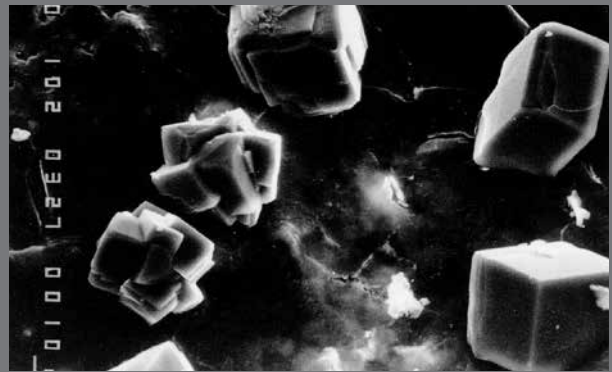
In the untreated image we can see precipitated calcium hydroxide particles and no crystalline growth. In the sample treated with Xypex Concentrate, we can see that at 50 mm (2 in.), an extensive crystalline formation has taken place, affording complete protection for the embedded reinforcing steel.

UNTREATED CONCRETE AT 50 MM

The essence of concrete durability is to protect the reinforcing steel of concrete from corrosion. Xypex achieves this by preventing the ingress of water and harmful chemicals. To assess the impact of Xypex on durability, investigators compared an untreated sample of concrete and a sample coated with Xypex Concentrate at a depth of 50 mm (2 in.), representing the standard cover depth of concrete over reinforcing steel.

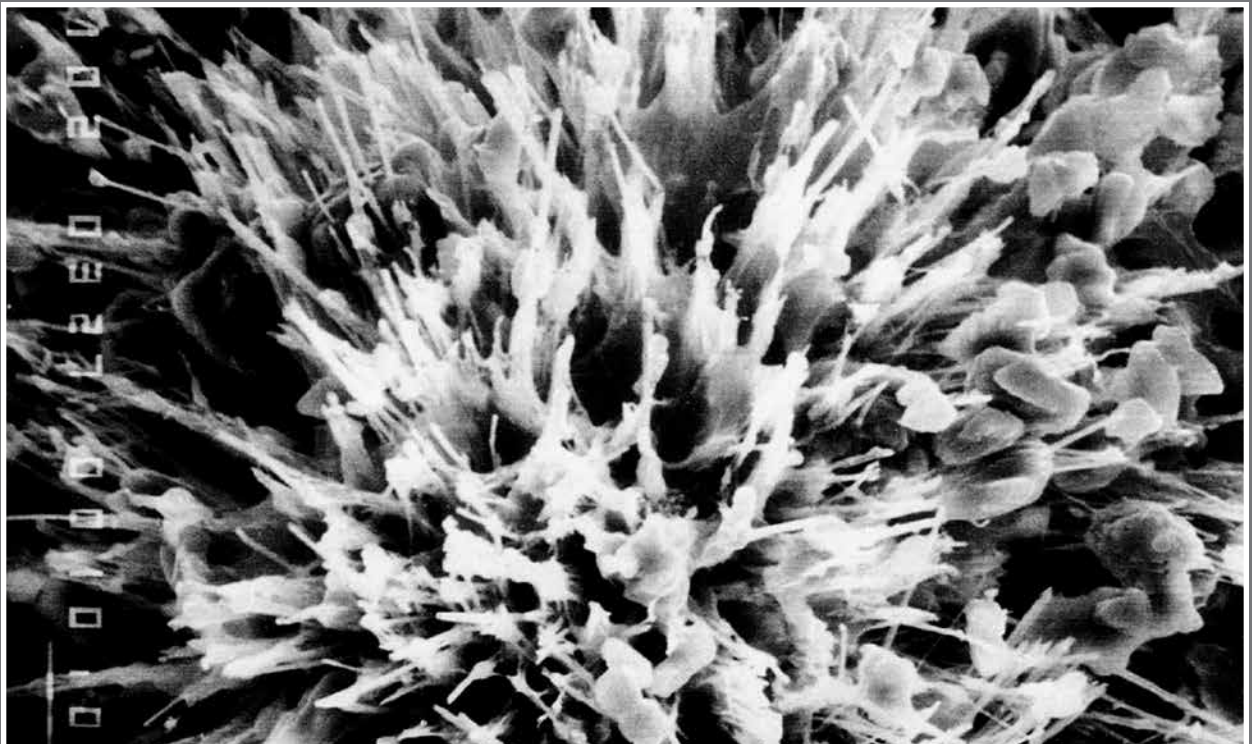
XYPEX CONCENTRATE AT 50 MM

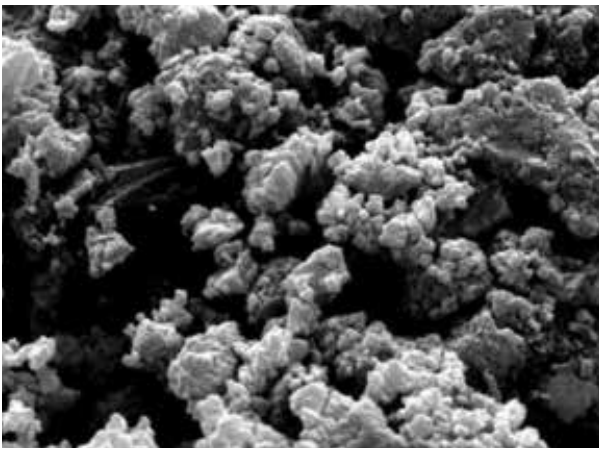
UNTREATED CONCRETE

Xypex was chosen to protect and waterproof the 1.5 m (5 ft.) thick upstream face of this 108 m (354 ft.) high, 704.5 m (2,311 ft.) wide, gravity dam constructed with roller-compacted concrete. Prior to selection, concrete samples were produced on site using exactly the same materials used in the production of the construction concrete. They were then subjected to rigorous testing, at all times comparing the performance of untreated samples with those treated with Xypex.

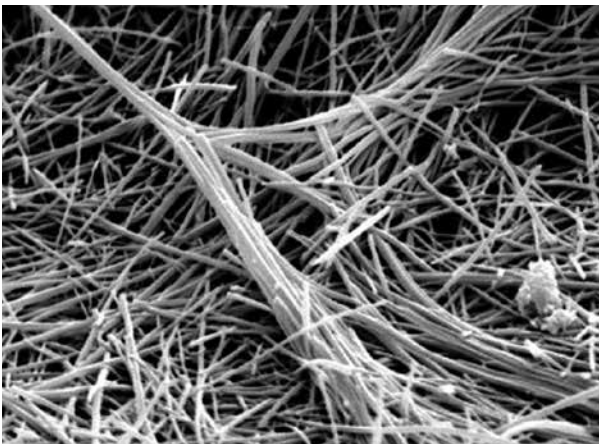
XYPEX TREATED CONCRETE

The SEM investigation of the same samples clearly illustrated the dense, crystalline structures formed within the Xypex treated concrete matrix, giving 100% protection to the face of the dam.

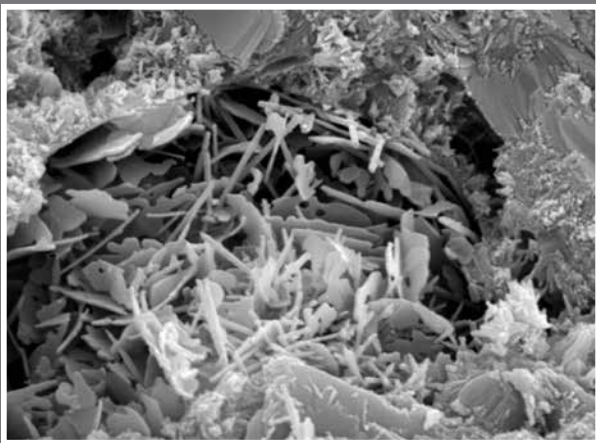
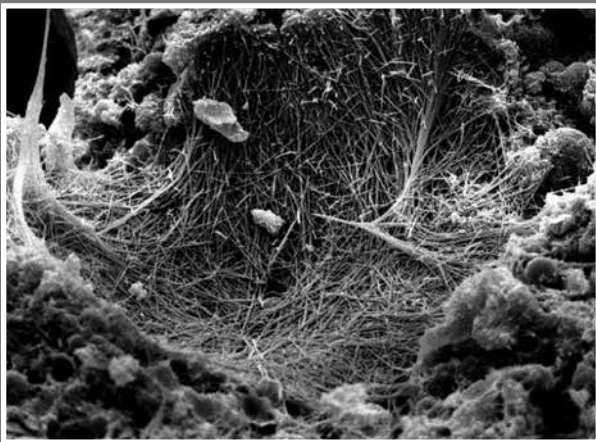
ELECTRICITY GENERATING AUTHORITY
OF THAILAND, RATCHABURI POWER STATION
SEM-113

XYPEX TREATED CONCRETE

The Ratchaburi Power Station is located on the estuary of the Mae Klong River and is exposed to destructive chloride attack. Xypex Concentrate and Modified were used to treat the 4-year-old roof decks of the cooling towers. Concrete cores extracted from the cooling towers were subjected to microscopic examination. In the SEM image taken at x7000 magnification and a depth of 20 mm, we see the developing crystalline formation interwoven with flat plate-like structures similar to calcium hydroxide. This formation protects the reinforcing steel from harmful effects of chloride attack.
